Byron Midair 11/7/2020

Ramy Yanetz

Feb 2021

Midair Investigation

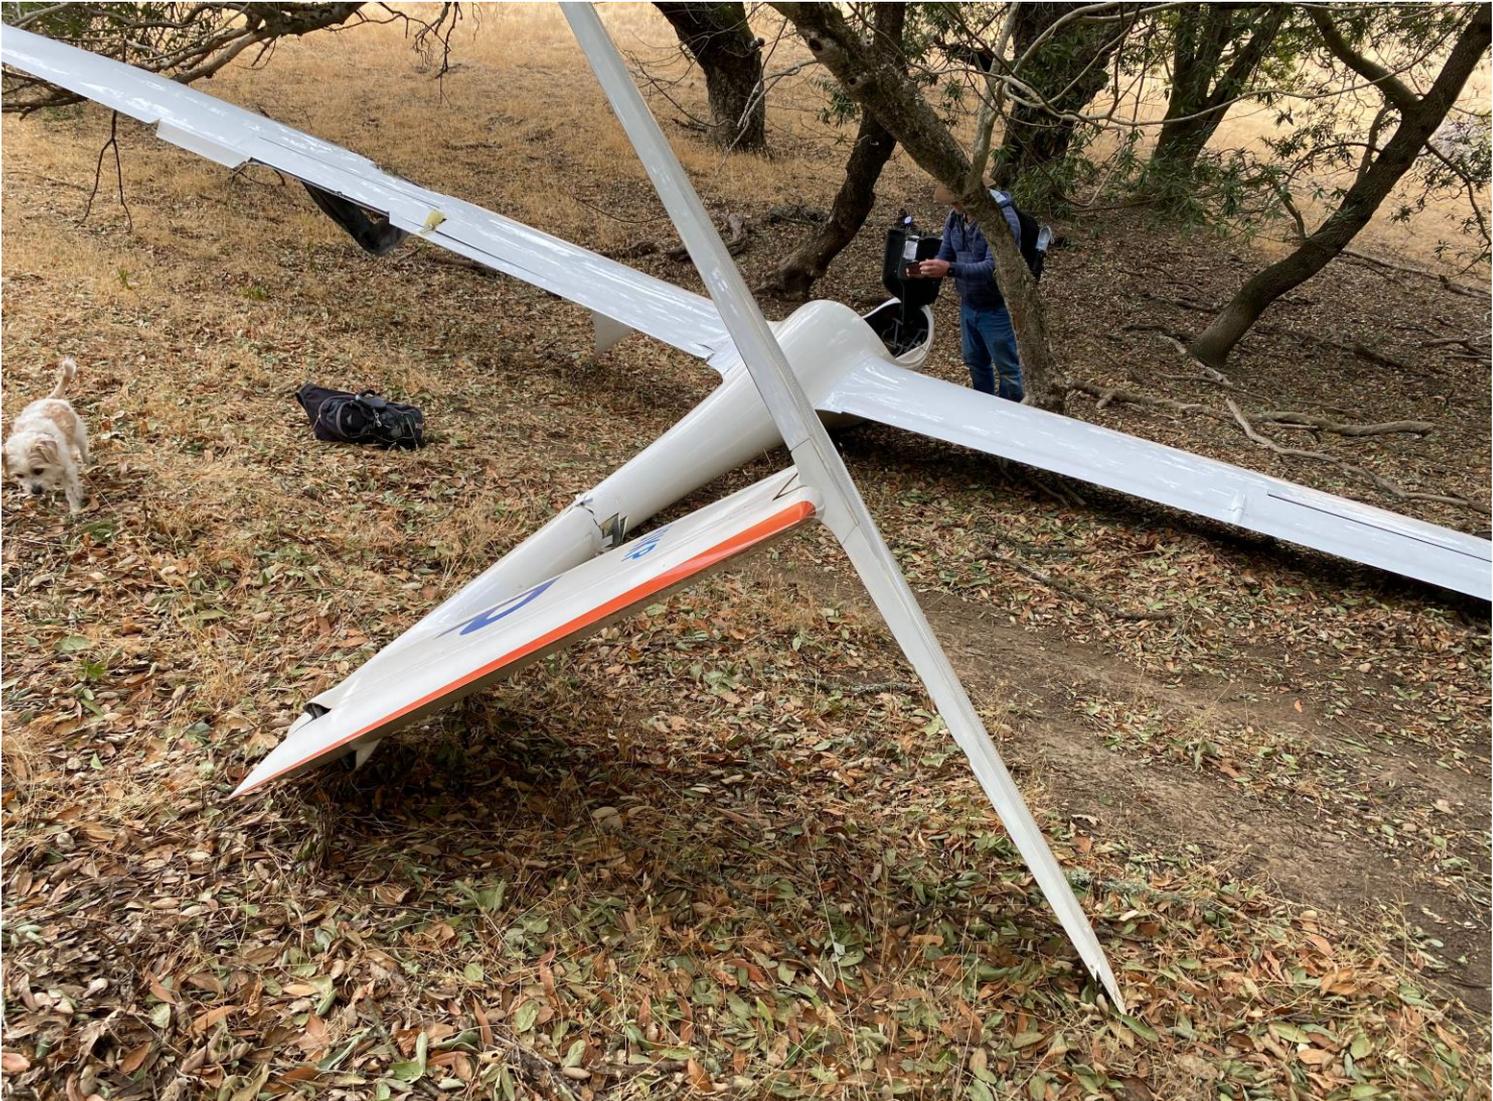
FP

- One pilot was seriously injured.
- Both gliders were remarkably intact with most of the damage from the mid air itself, most likely due to entering flat spin after bailout.
- “MA” was stuck in the trees and was missing few feet of the left wing tip.
- “FP” had substantial damage from the midair to the wing and control surface near the center of the left wing. It only sustained additional damage to the tail boom upon impact with the ground.

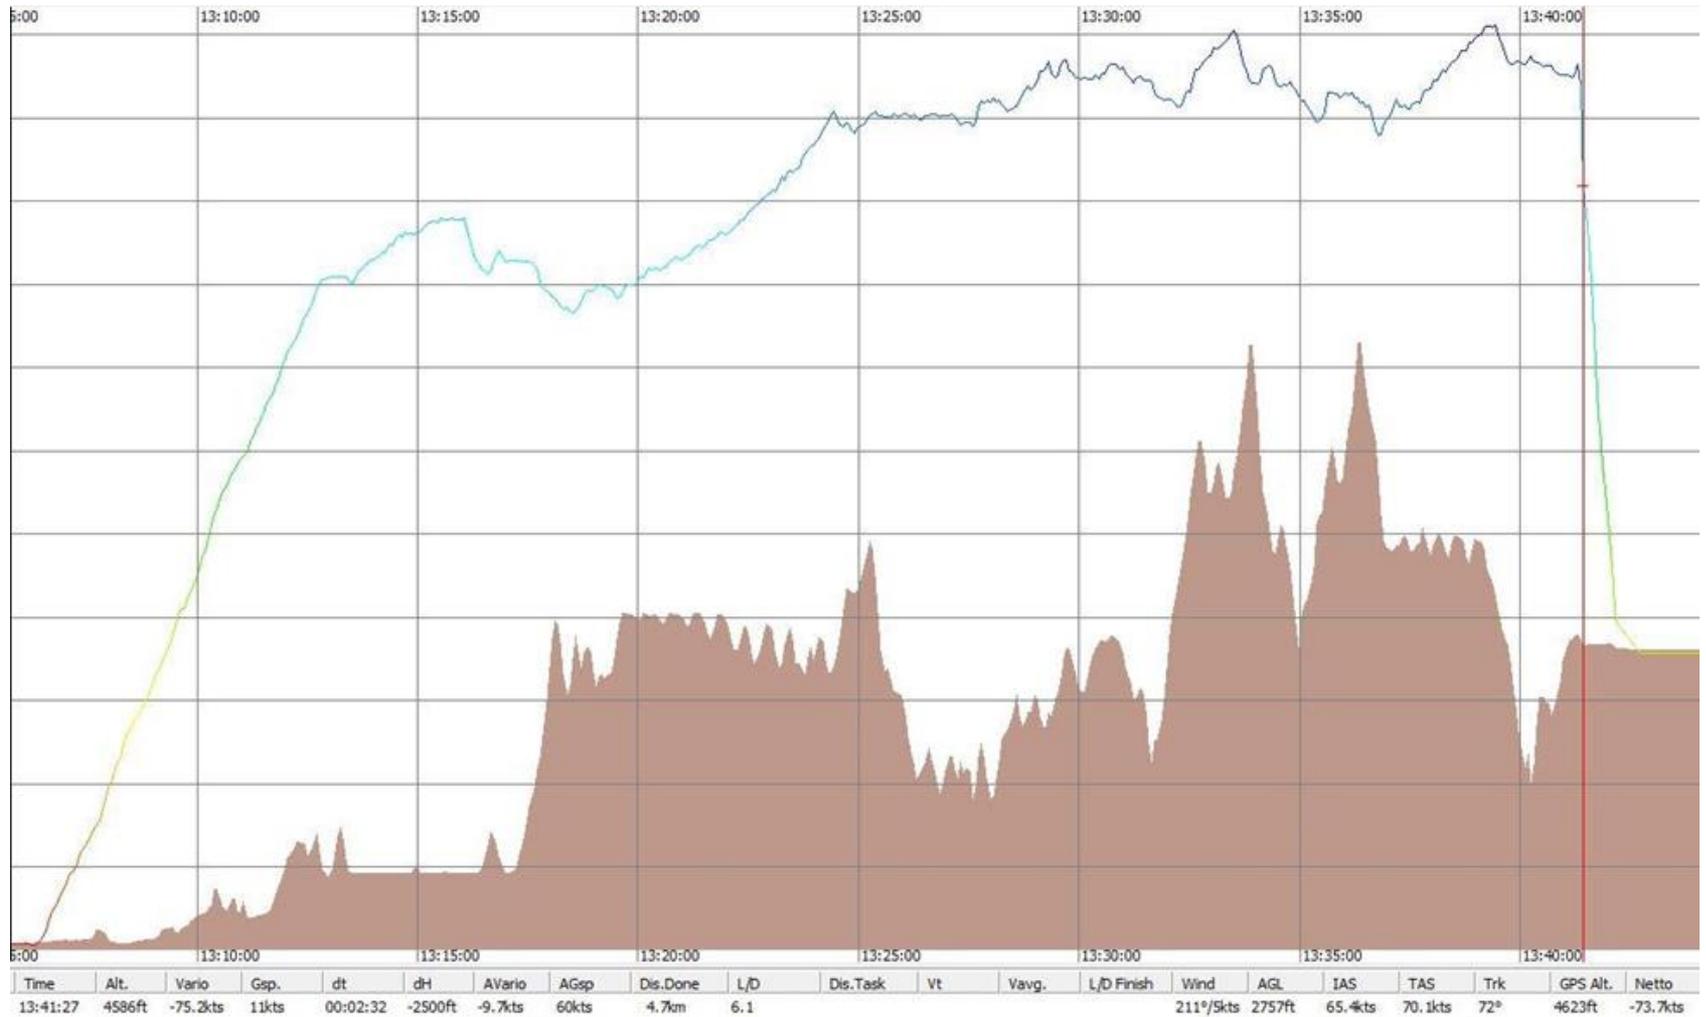
FP Altitude Trace

- FP Maximum sink rate recorded was around 75 knots vertical dive (7000 fpm about half of free fall speed)
- FP lost the 1st 1000 feet in 10 sec (6000 fpm), the next 1000 feet in 15 sec, the 3rd in 20 seconds.
- FP sink rate slowed down significantly to only 400 fpm for the last 200 ft and it took another 30 sec to hit the ground for a total of 1:20 minute from collision to ground.
- MA Initial rate of descent 72kt for about 11 seconds, reducing to 30kt (presumably after bailout). Remarkably similar to FP.
