Northern California Soaring Association

N3981C System Documentation

January 2021

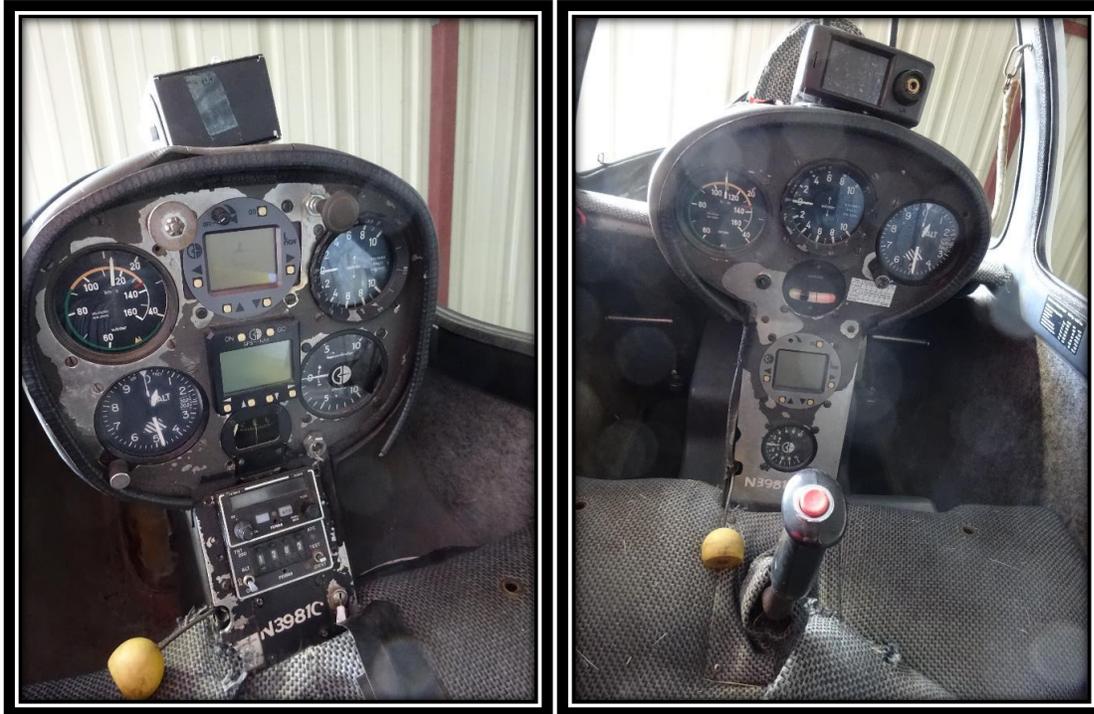
Figure 1: Legacy front and rear panels

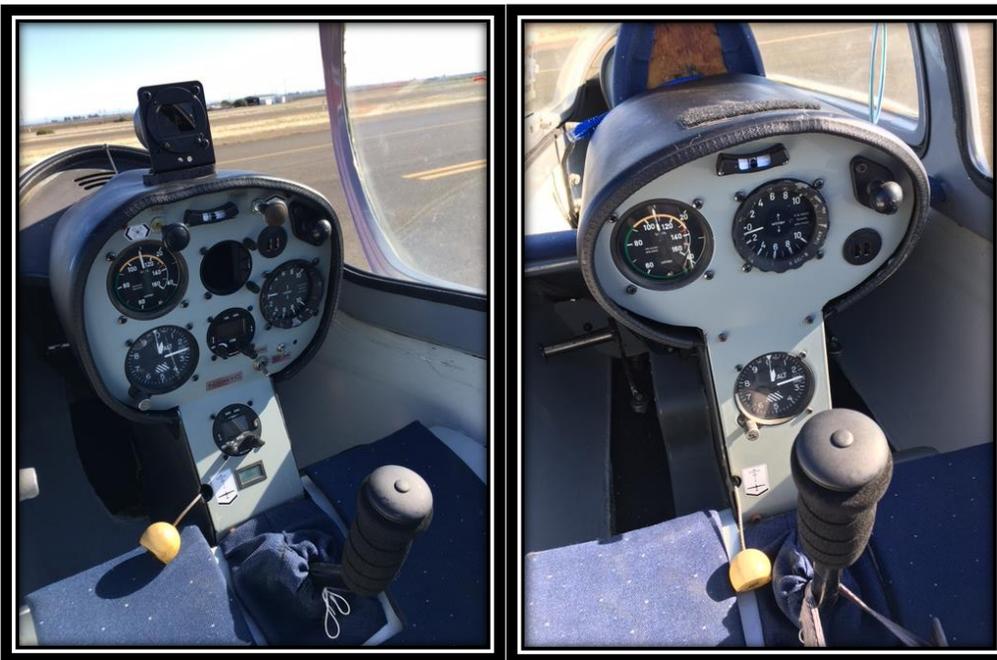
Figure 2: Panels after refurbishment project

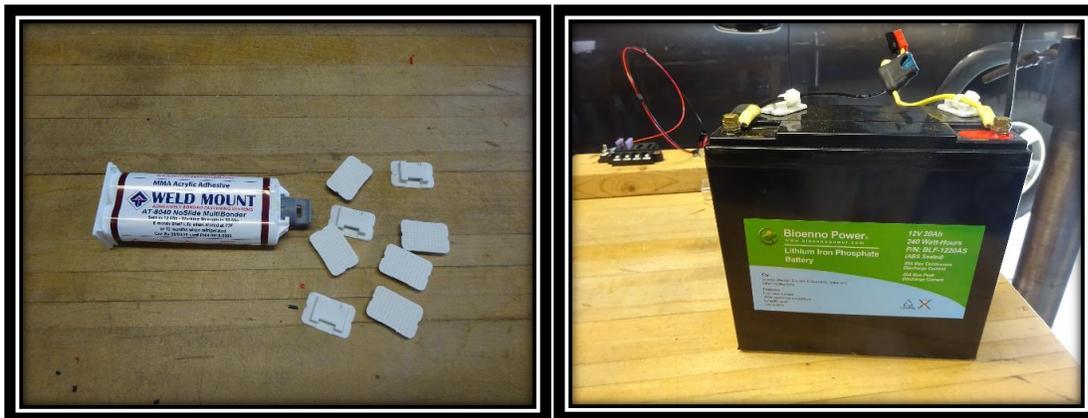
Figure 3: Weld Mount cable tie anchors, 20 Ah LiFePo Battery

The wires from the battery are continuous 16 gauge terminating at the Master Switch (+ Lead) or Ground Buss. During disassembly, multiple, casually implemented splices were discovered along the length of the main power leads. Future branch circuit connections should be made at the fuse block and ground buss to maintain the integrity of the current build.

The battery tray was fabricated by Tap Plastics from ABS plastic. Fit-up testing showed that the ABS to battery interface was excessively slippery. To mitigate this, neoprene rubber was bonded to the bottom of the battery to provide better surface to surface adhesion. The tie-down is a simple camlock strap that is threaded through a channel in the bottom of the battery tray. Similarly, the wires leading to the battery pass underneath the tray in a channel cut for this purpose.

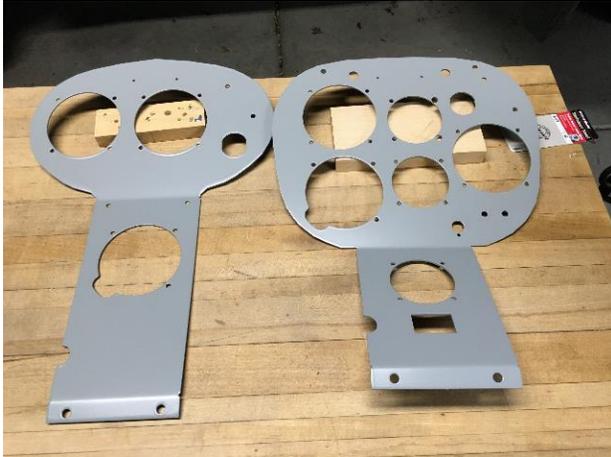
to provide better adhesion. Unfortunately, after several coats of clear coat, there was a significant fade in the labels either due to the opacity of the clear coat or chemical fading. While still visible, some of the labels are faint and are candidates for replacement in the future.

Figure 6: New panels after powder coating

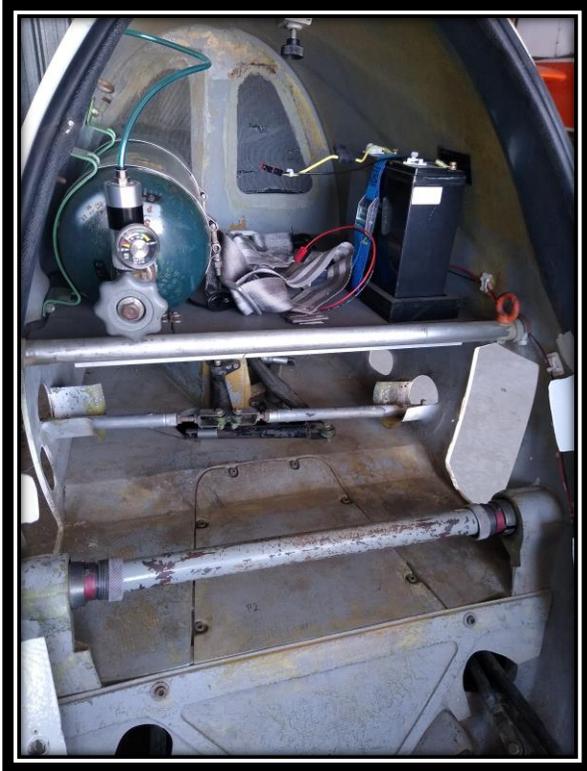
Figure 9: O2 Tank and Regulator

Except for the oxygen tank and its mounting harness, the legacy oxygen system was completely removed and replaced. The tank itself was 4 years out of hydro test compliance, so the tank received a fresh hydro test and fill. This service was procured through Maintenance Express at the Livermore Airport.

A new regulator and distribution hardware were procured from Mountain High and installed in 81C. The regulator configuration is different than used in KP in order to have a more compact footprint for the valves and fittings (Figure 9).

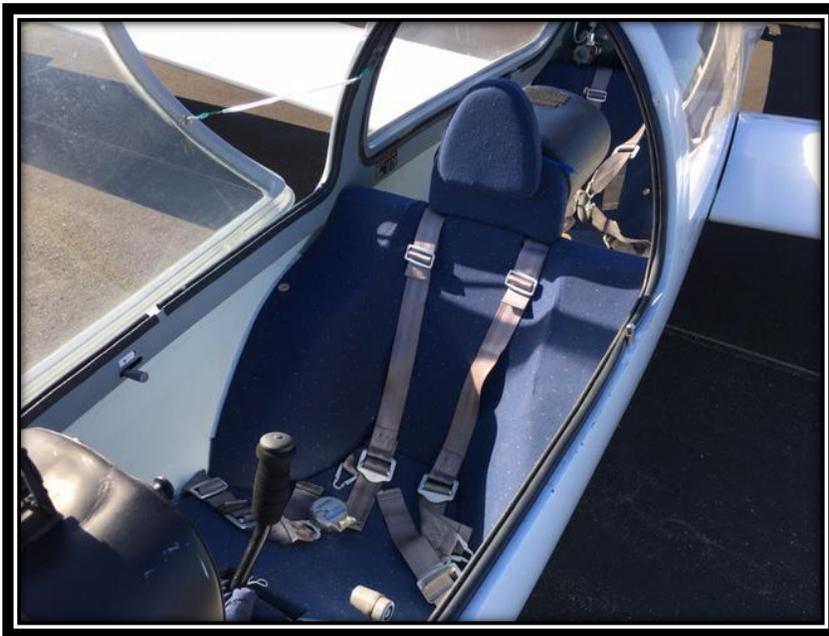
The interior sidewalls of 81C were covered in carpet that was badly deteriorated. The old carpet was removed and the sidewalls were cleaned to remove old contact cement residue, prepped and primed with Interlux Prime-Kote polyurethane primer. After priming,

Figure 10: Cockpit After Painting and Seat Upholstering

The fabric and upholstery on the seats and headrests was badly deteriorated. The seats were stripped, sanded and painted. New upholstery was fabricated and installed by Michael Demeyer.
