# Northern California Soaring Association

## N132SS System Documentation

April 2018

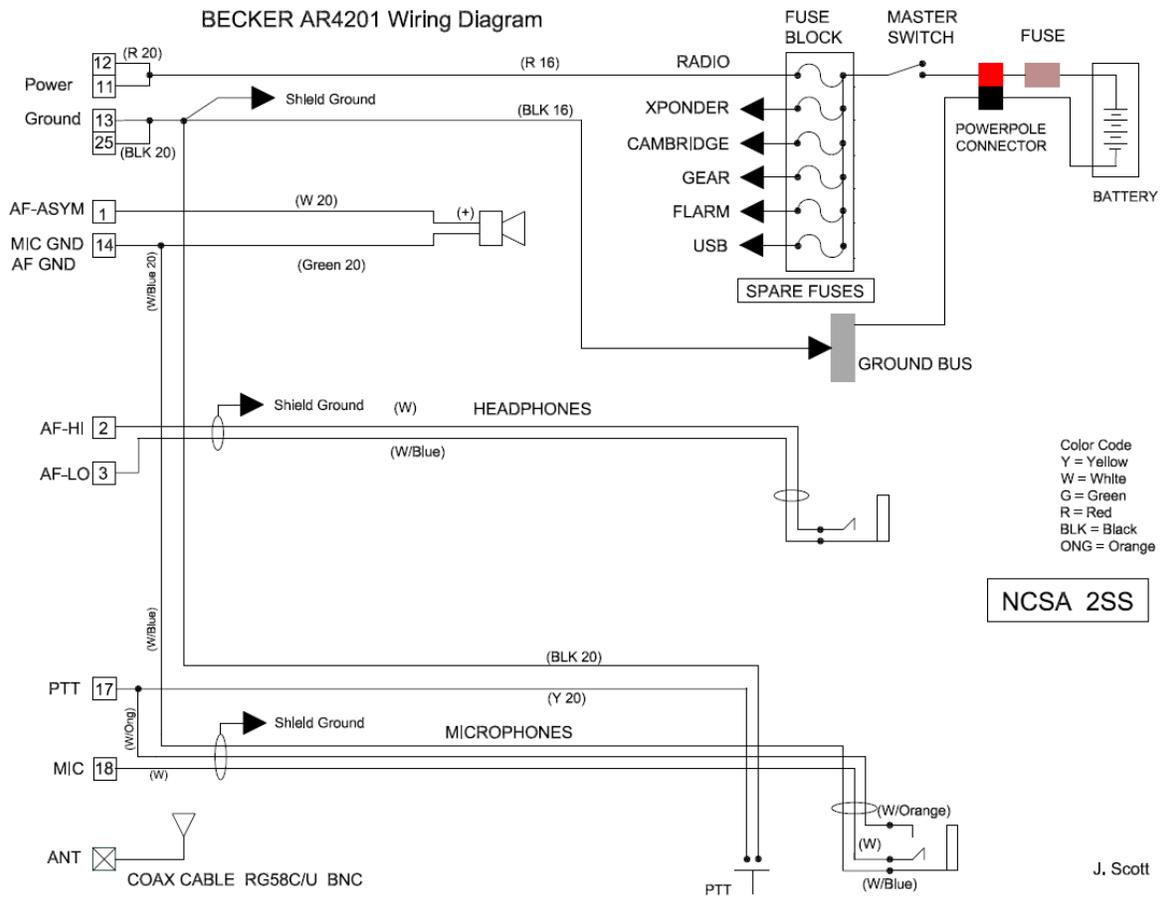
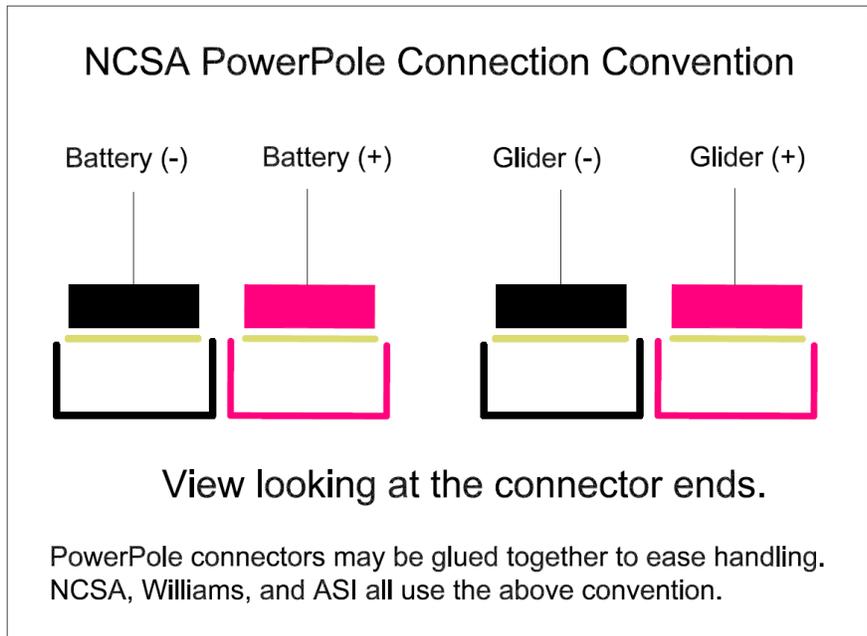
# Electrical Circuit Diagram

The comm radio did not work and was removed. The old wiring harness was a jumper cord designed to convert from the old radio connector (AR3201; DB15) to the newer radio (AR4201; DB25). This harness was a bit rough looking and was in need of replacement. The old configuration had 3 panel mounted fuses, an inline fuse for the Cambridge units, and no fuse protection at all for the gear warning circuit. The new configuration has an eight (8) position fuse block of which six (6) positions are used. The remaining two (2) positions hold spare fuses. See circuit diagram.

Prior to starting this project there was a meeting of the "Radio Group" to discuss objectives and guidelines. The lithium battery and Powerpole connectors were decided in this meeting. The use of an internal fuse block was also agreed to in this meeting (as opposed to circuit breakers reachable in flight). It was also agreed to protect the battery with either a fuse or a non-self-resetting circuit breaker. It was agreed that the speaker would be wired permanently on (no switch). The lithium battery is rated for 20 amps. It is protected with a 15 amp fuse. All branch circuits are protected with 5 amp fuses. To minimize voltage drops, all wire current ratings exceed these fuse amp ratings. The battery supply wires are 16 AWG and all branch circuits are either 18 or 20 AWG.

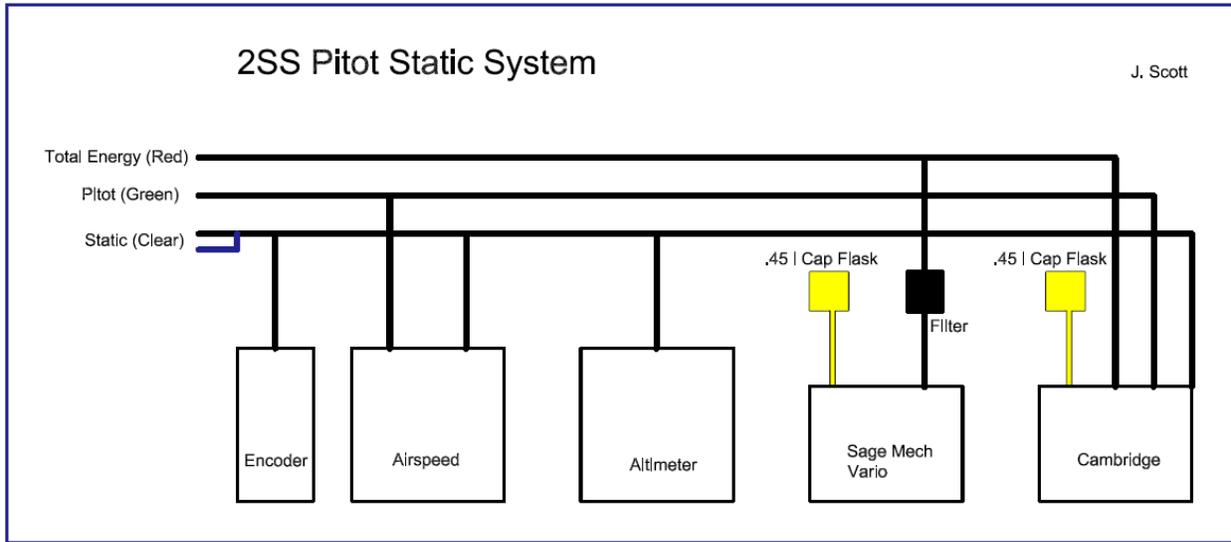
# Pitot Static Diagram

set of holes in the back boom. Nobody, including the documentation manuals, could explain to me why there are three sets of static ports. As it came to me, the rear static system was capped off and the two front systems came up as independent static lines to run the instruments. I joined the two front systems together down below and brought up a single static line for the instruments. See Pitot Static diagram. The old and new tubing follow the standard color code system (Green=Pitot, Red=TE, Yellow=Capacity; Clear=Static).

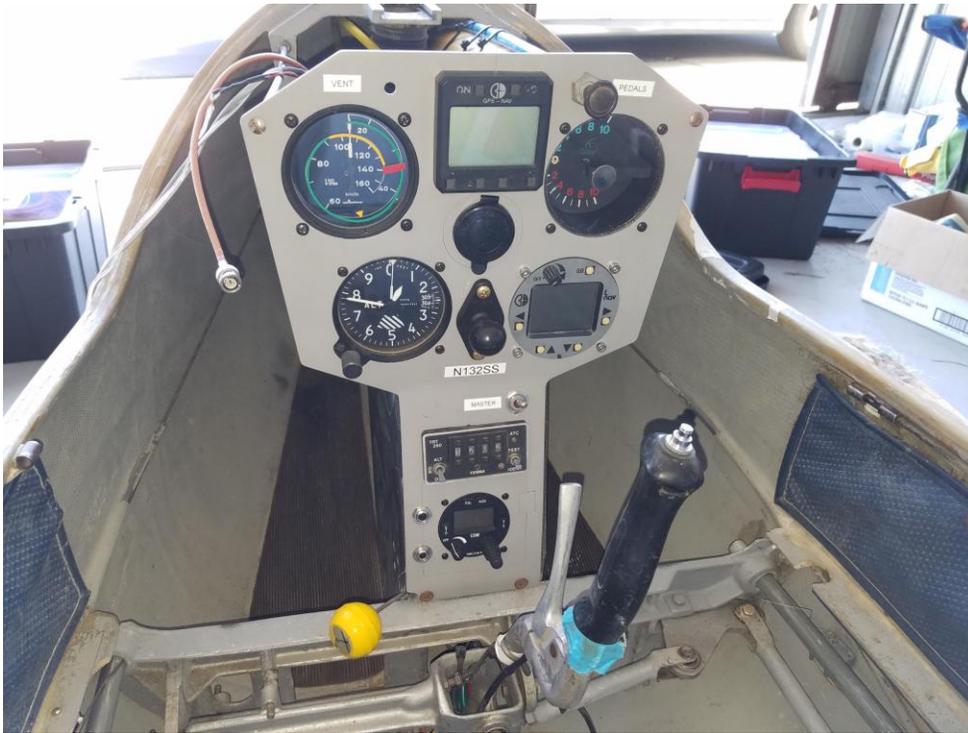
New Panel

The instrument panel went to a machine shop to be modified. Several unused holes were filled. The panel was modified to add the USB power port and a Ram mount. The original plan was to have the panel sand blasted and then powder coated. However,

the paint had to be removed for the sheet metal mods so the original paint was removed with paint stripper. The lead time to powder coat was 2 weeks and we did not want to wait that long so the panel was spray painted using an SEM product (Storm Gray 15763) and then covered with a satin clear coat.

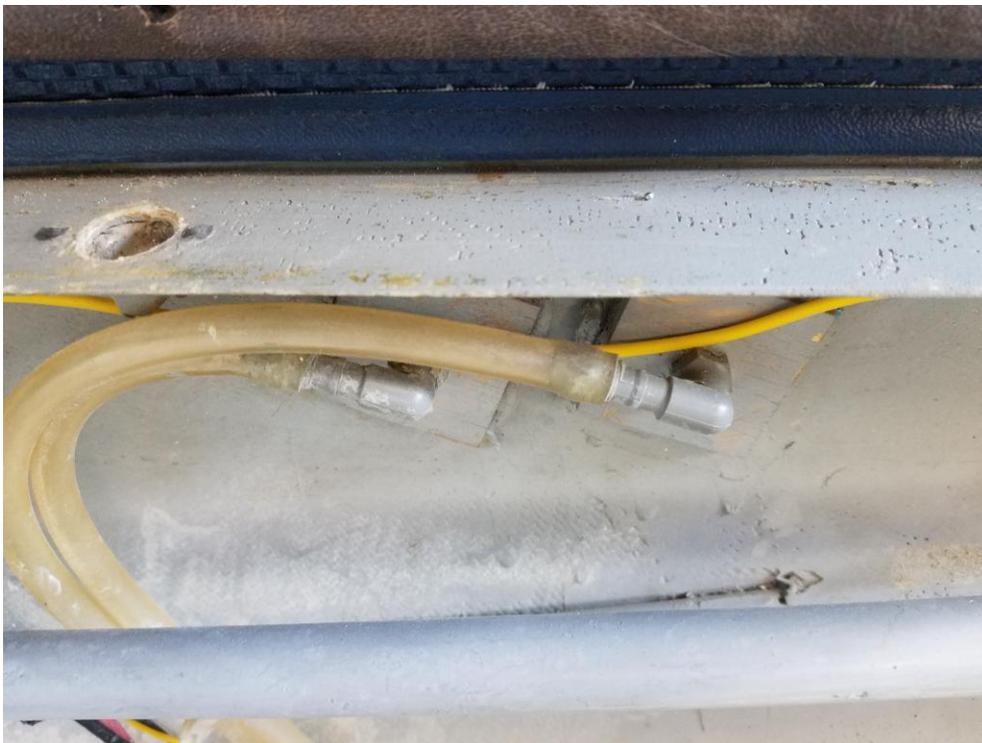
2SS has a dual set of static ports in front; two (2) holes on each side.

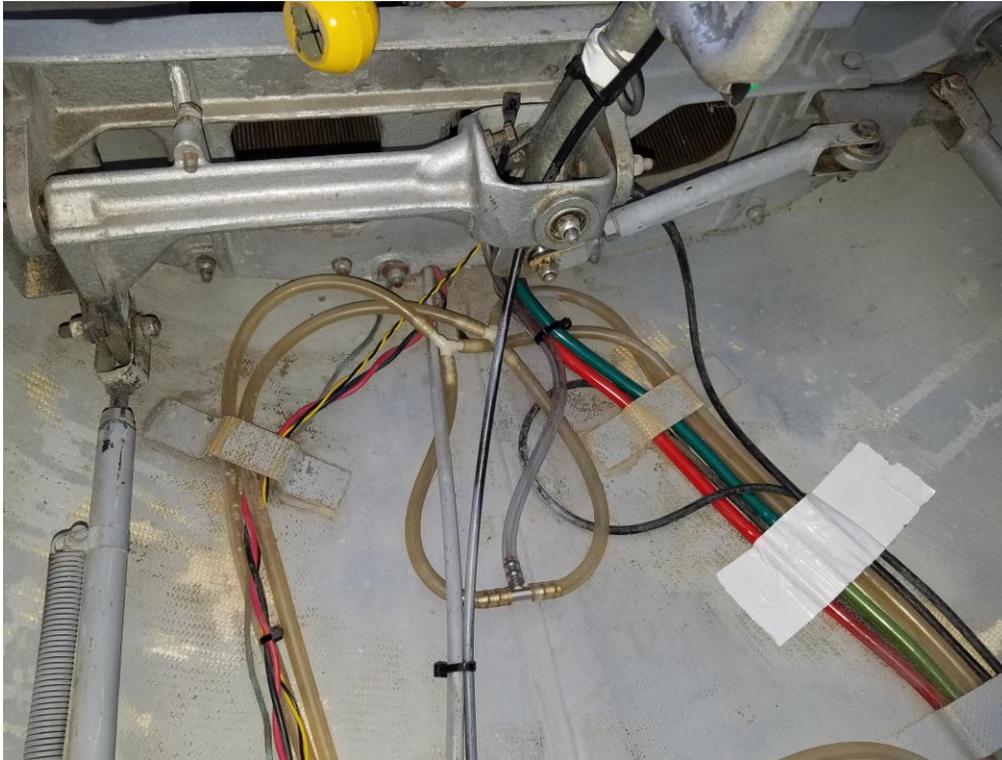
All four (4) forward static ports are plumbed together to a single static tube that then goes to the instruments.

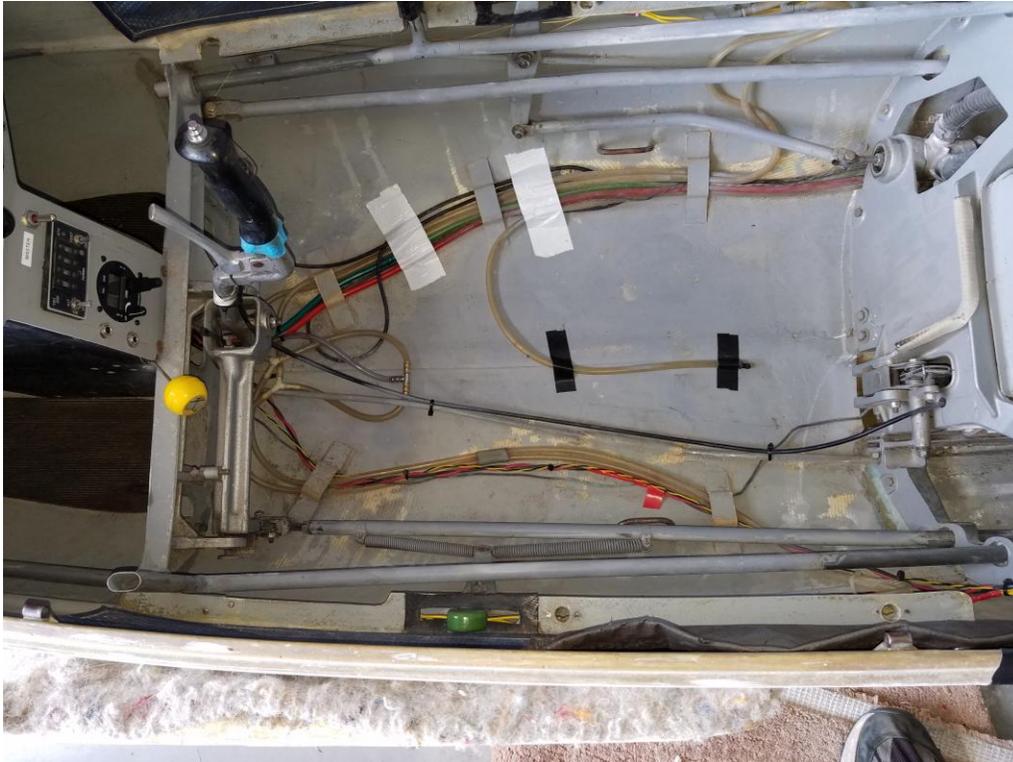
Rear static line is capped off.

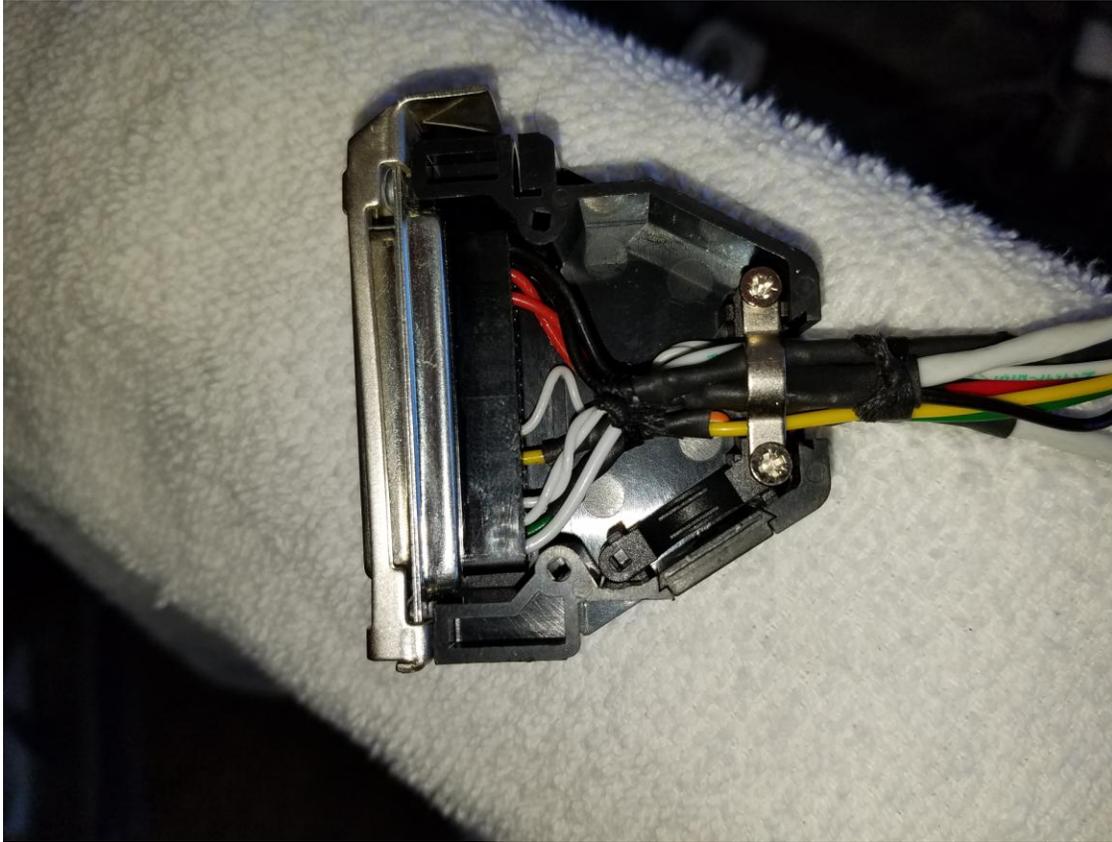
New harness.

The new wiring harness DB25 connector was assembled using mil spec crimp pins rather than soldering which is common for less experienced technicians.

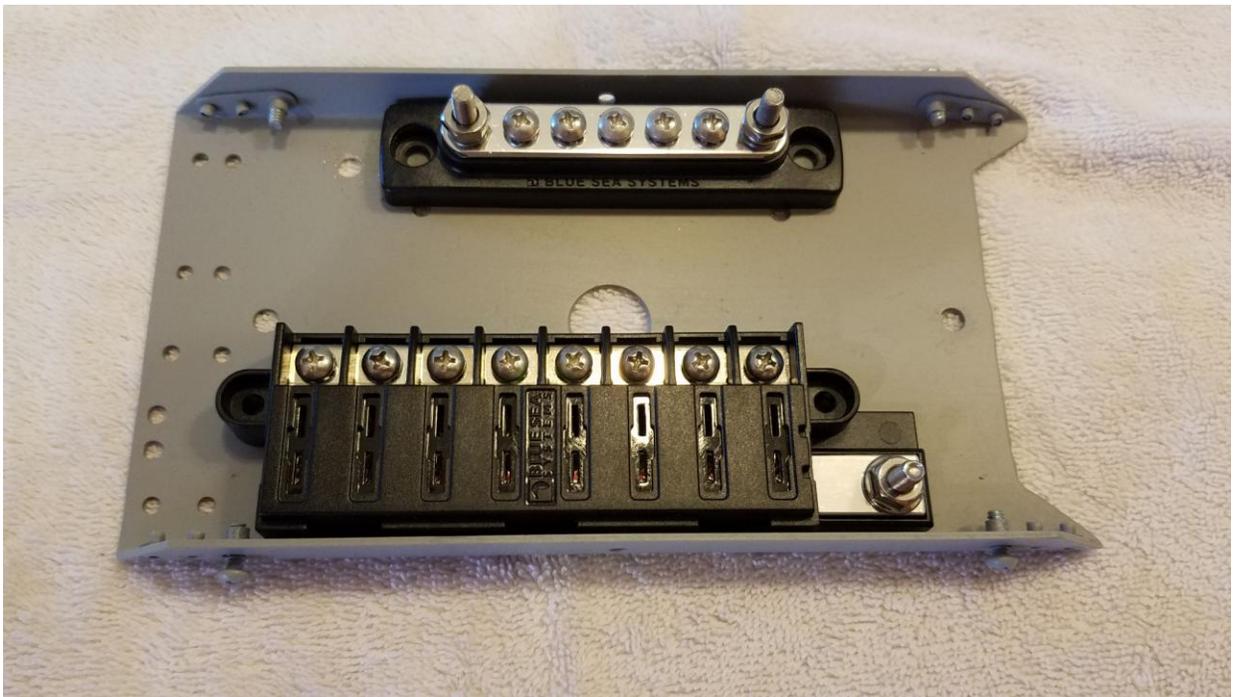
New power distribution panel.

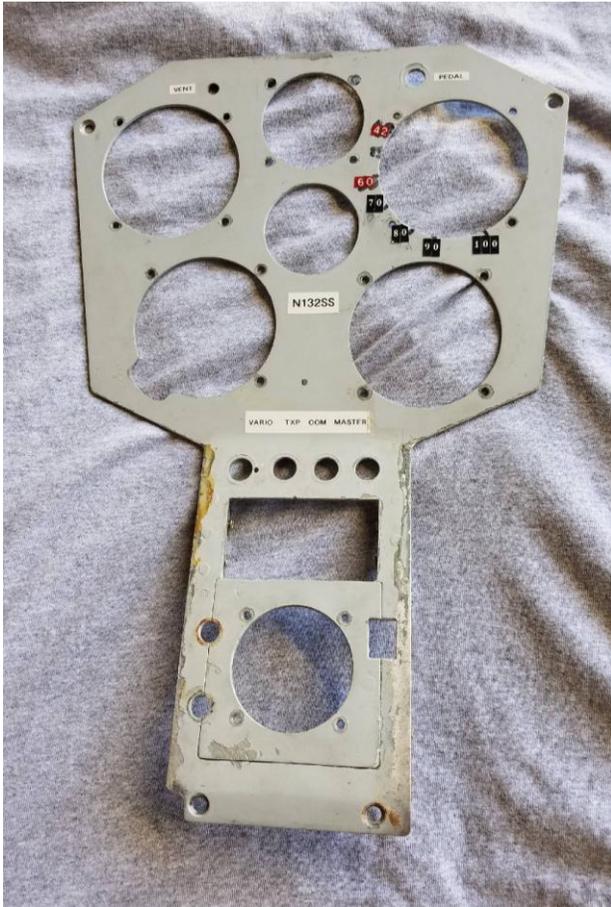
Old Panel

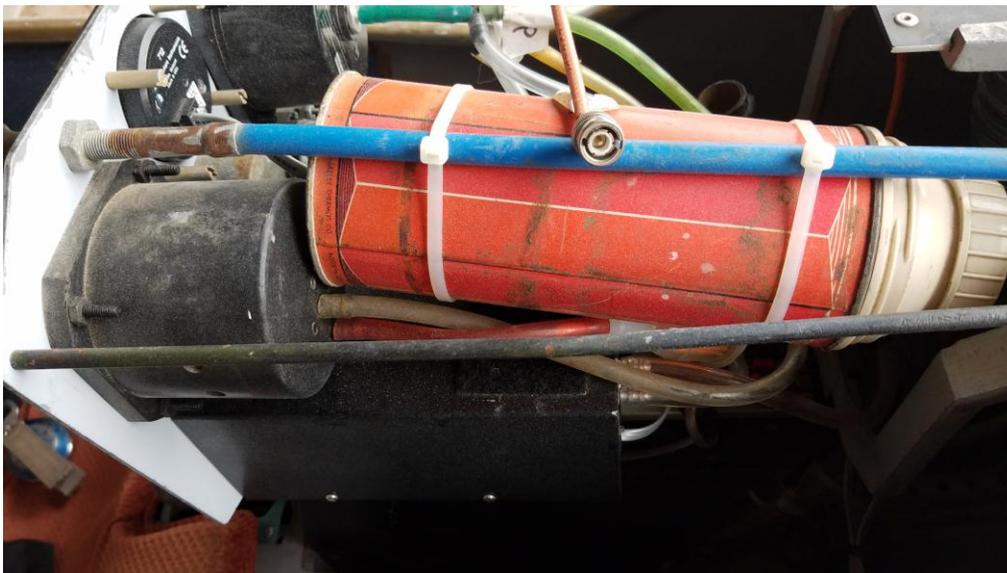
Previous technician saved some money by using a Thermos Bottle as a capacity flask.

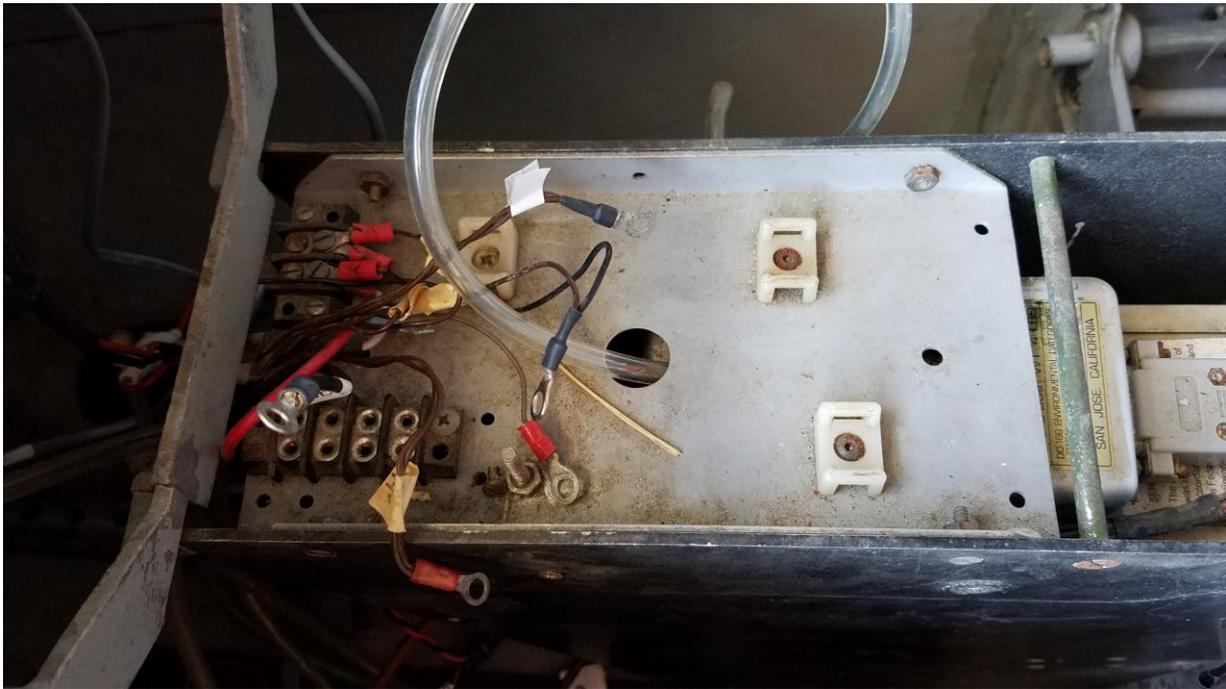
Old power distribution panel.

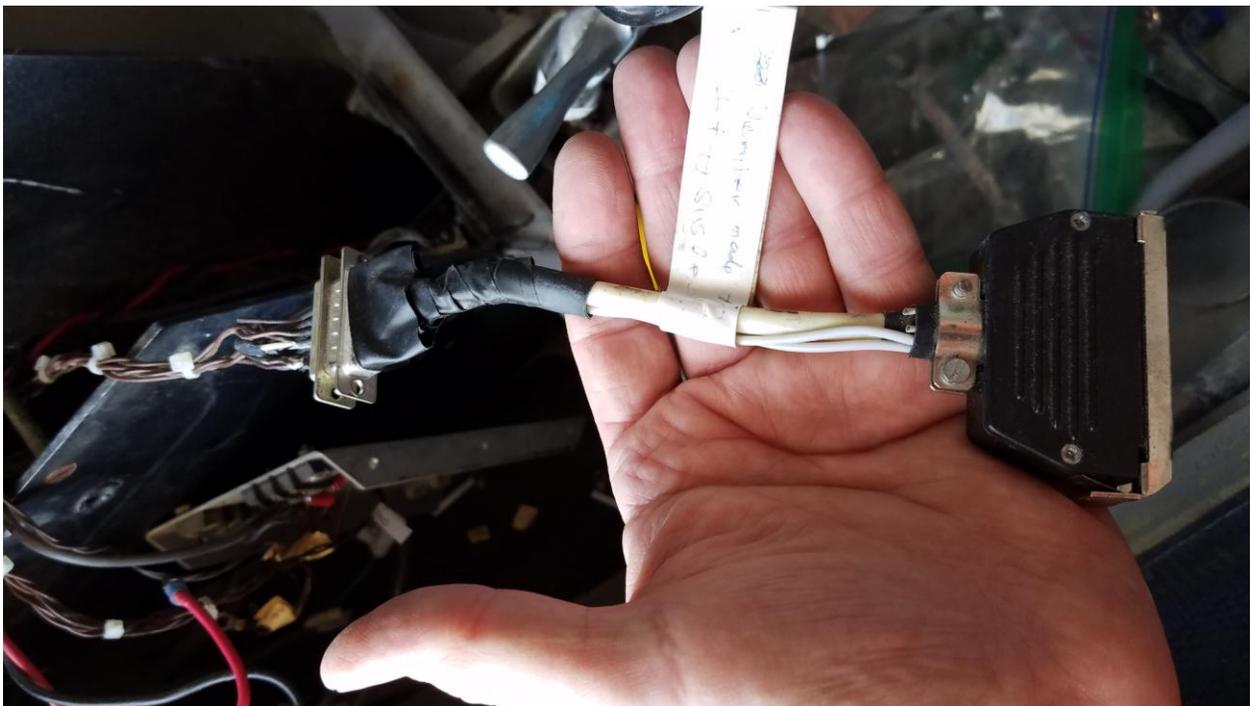
Old wiring harness with conversion jumper.

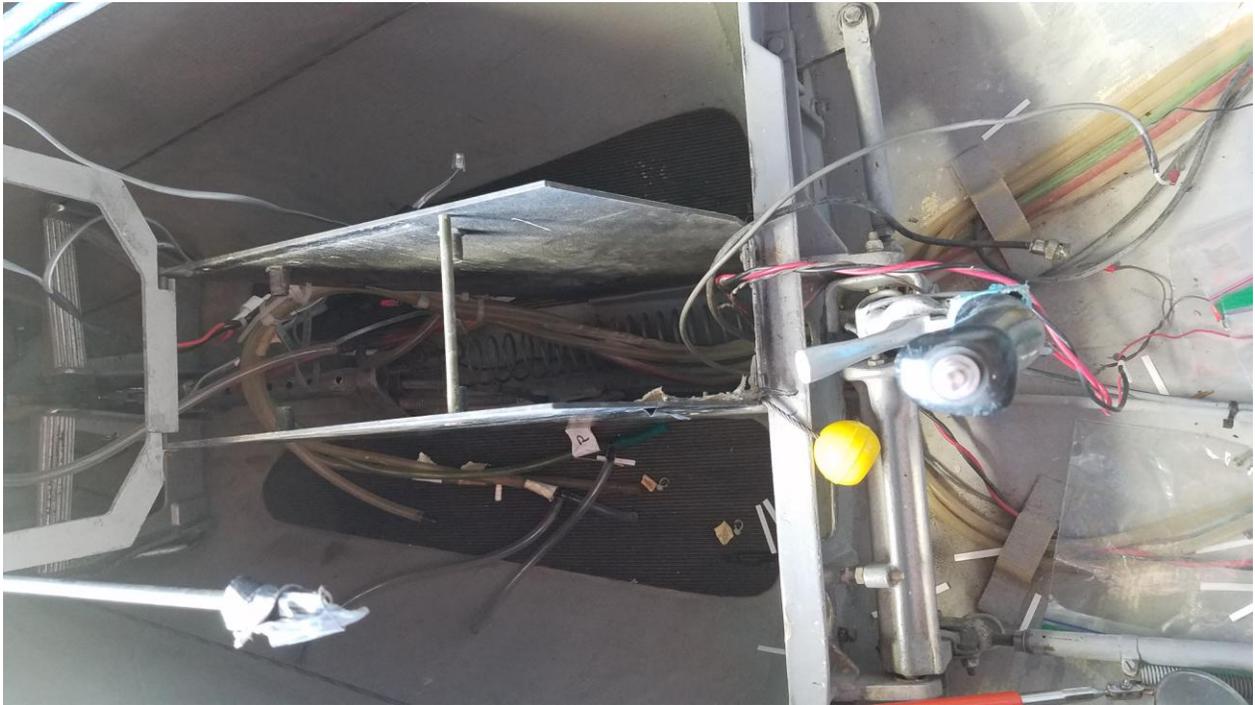
Gutted panel.

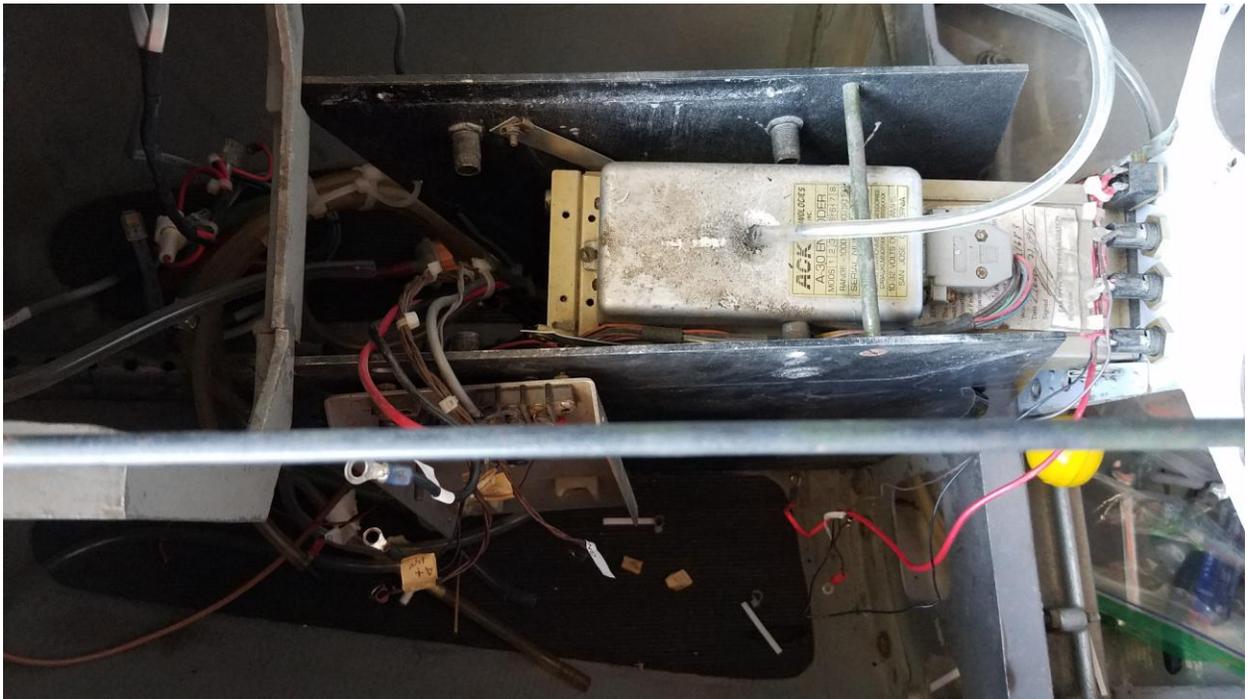
The long case for the Terra transponder must be supported in the back. Note the vertical support straps.
