Byron Midair 11/7/2020

Ramy Yanetz

Feb 2021

Midair Investigation

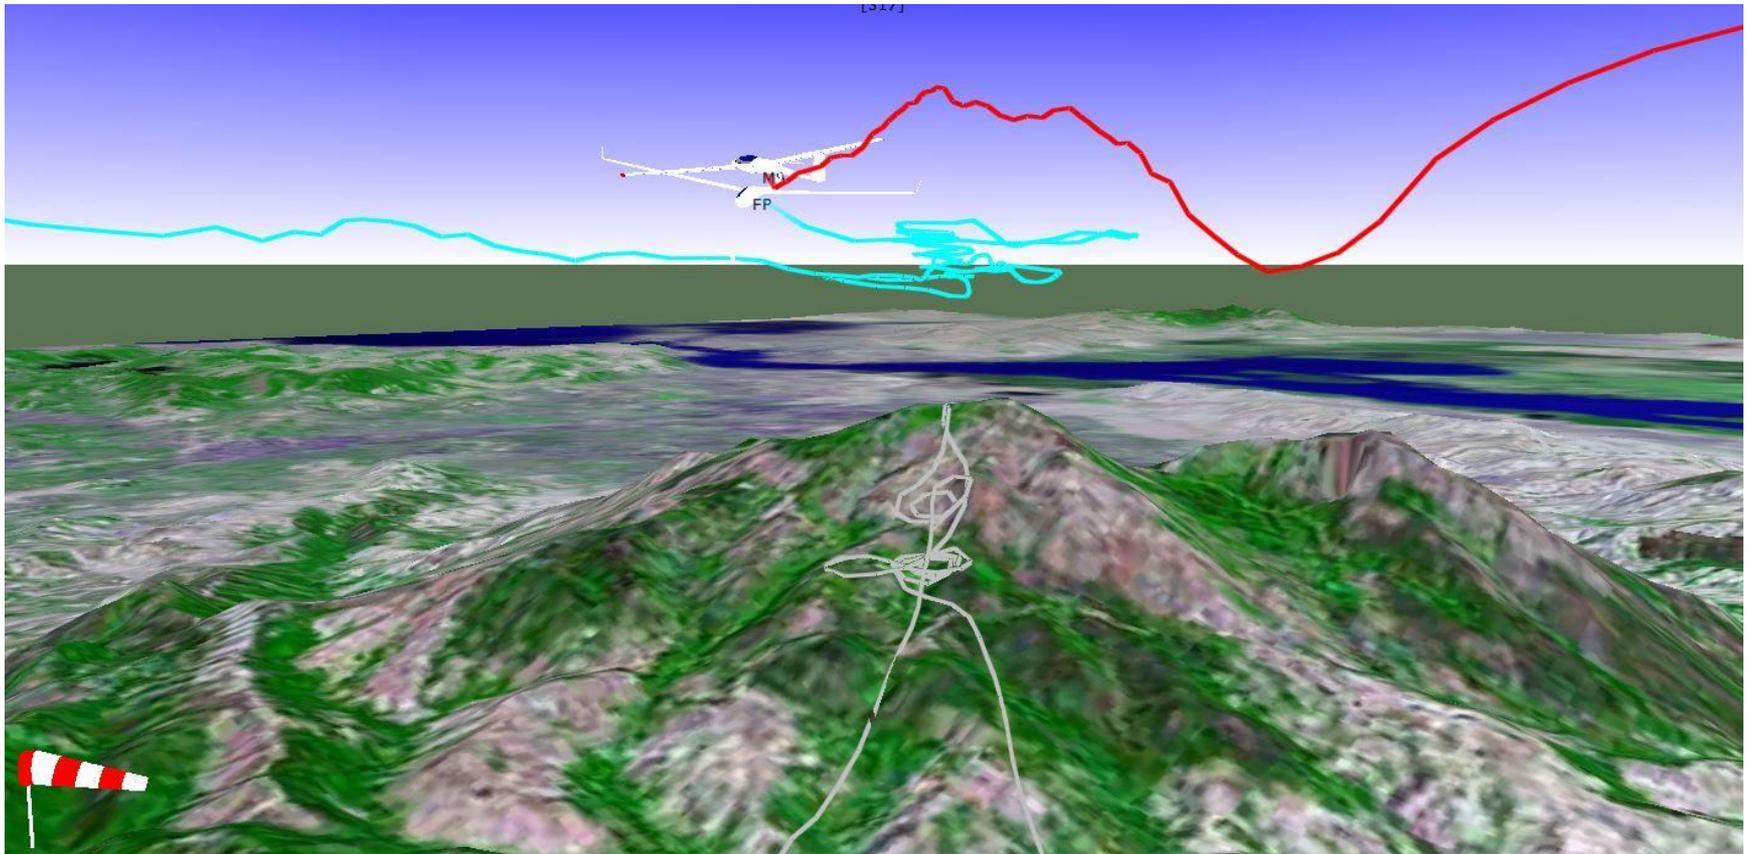
SeeYou 3D simulation

- Midair happened at 5300 feet (3000-3500 AGL)
- Both gliders were cruising at around 60 Knots in opposite direction 45 degrees to each other. They hit each others left wing in a slight bank.
- The pilots were not aware of each other, were not in radio communication and did not see each other until a split second before impact with no time to react.

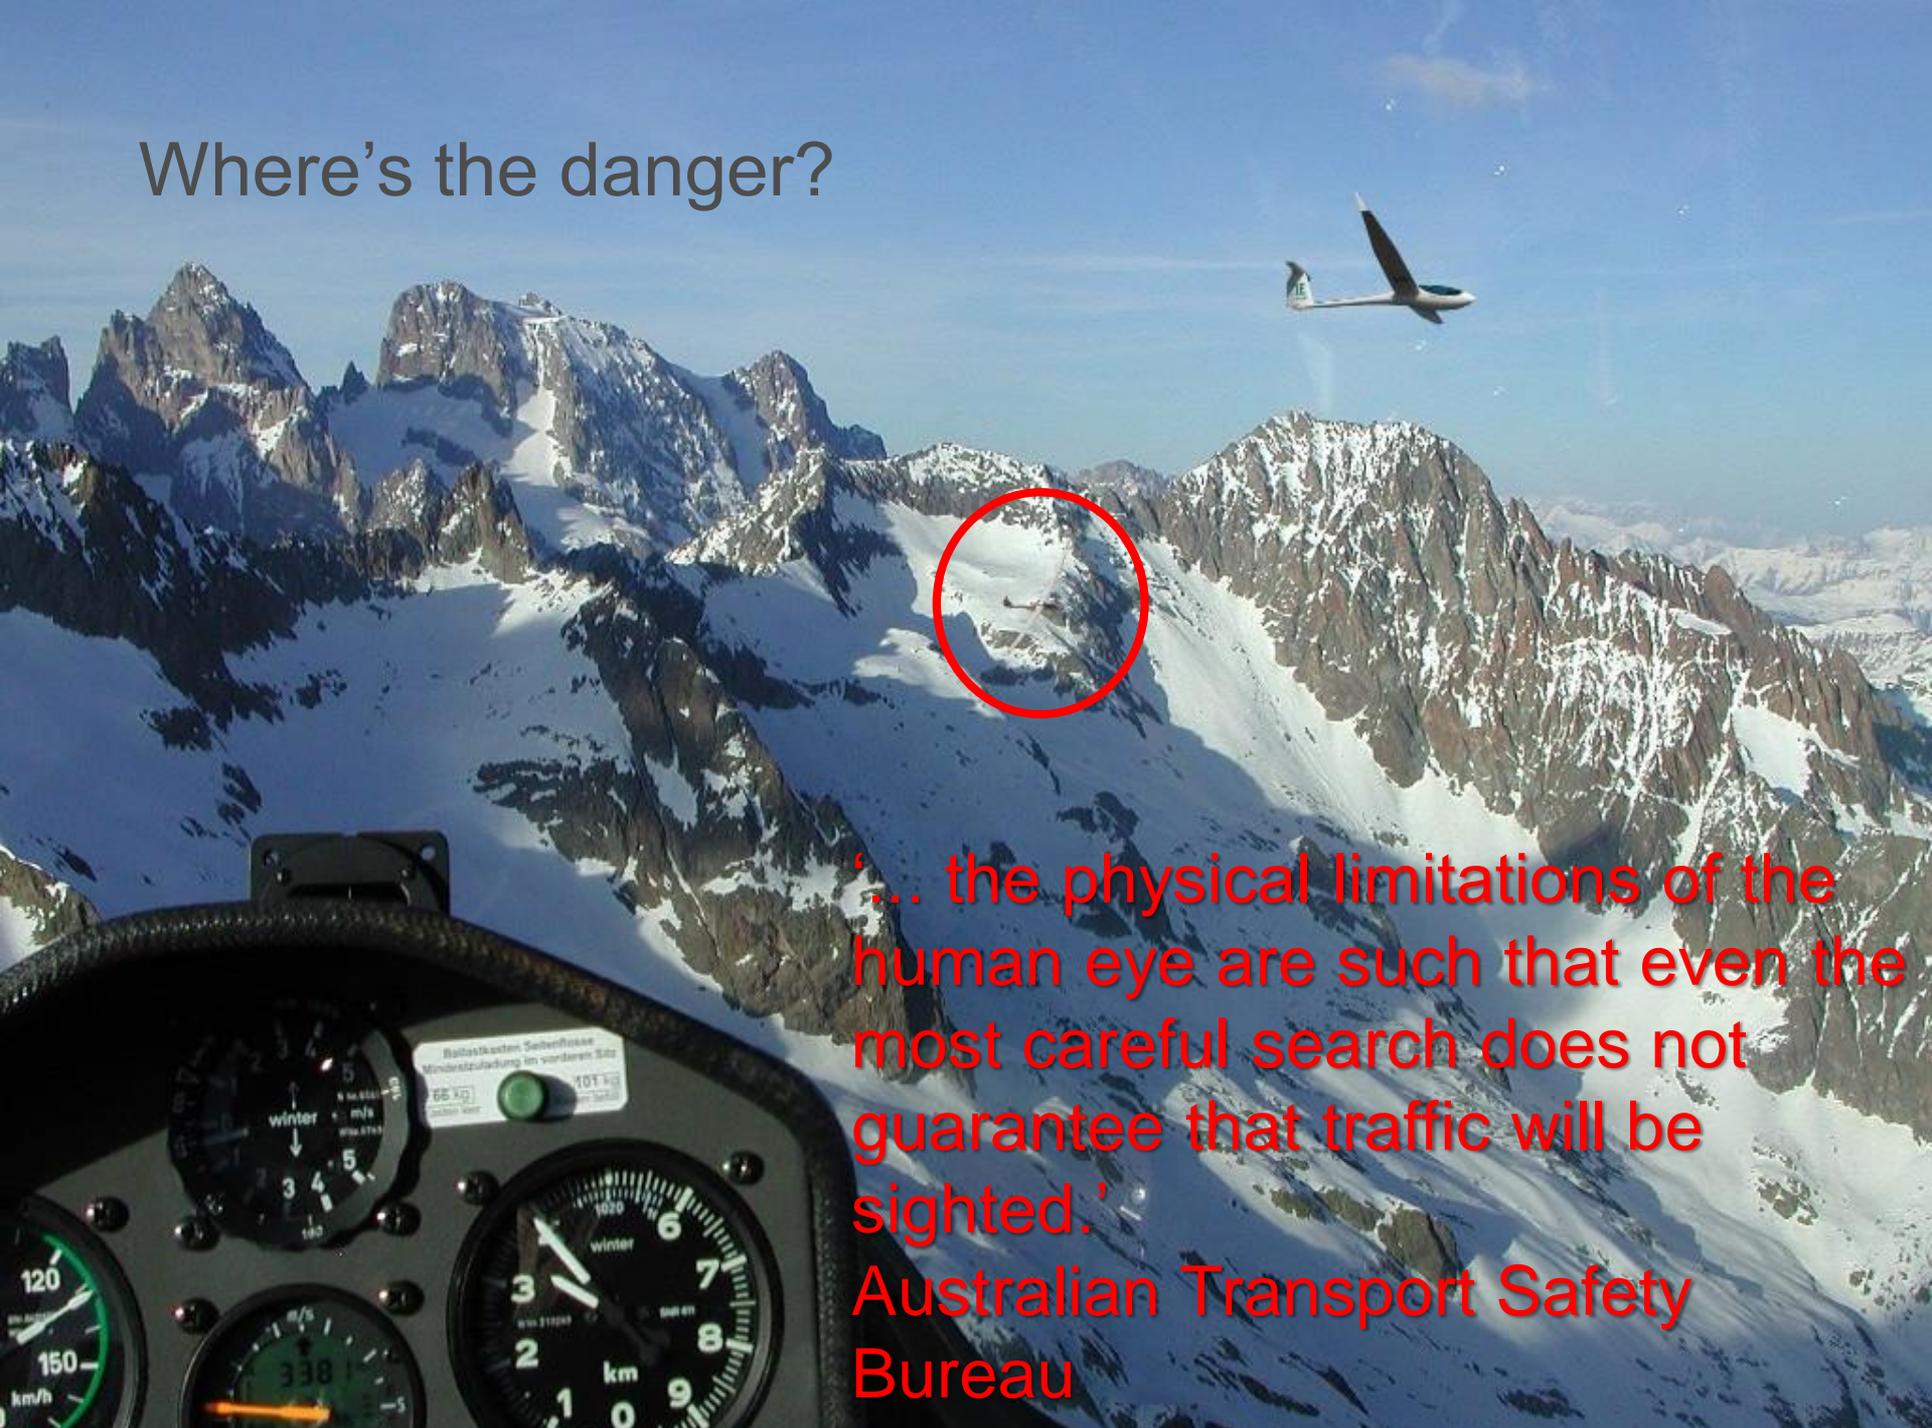
Where's the danger?

- See and avoid works poorly outside the traffic pattern or gaggles, especially for gliders cruising under cloud street
- Big Sky Theory – not working well for gliders

‘... the physical limitations of the human eye are such that even the most careful search does not guarantee that traffic will be sighted.’
Australian Transport Safety Bureau
